**Flood Control Project Maintenance
Levee Inspections**

Fall 2009 Levee Maintenance Deficiency Summary Report

San Joaquin River Basin

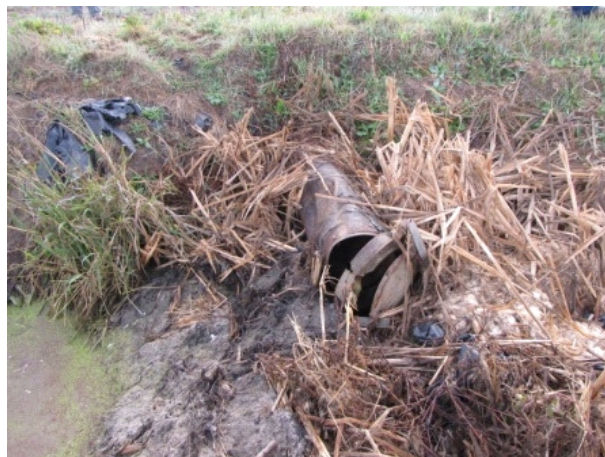
dpesaven_20091124_517.jpg

View of pipe and flap gate damaged and non-operational.

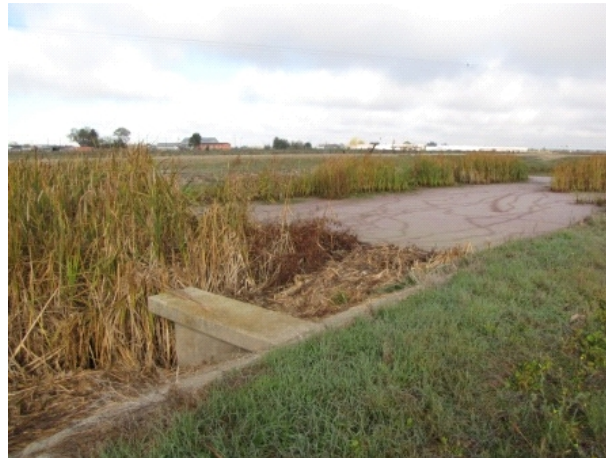
dpesaven_20091124_515.jpg

View from downstream of earthen dam in the channel.

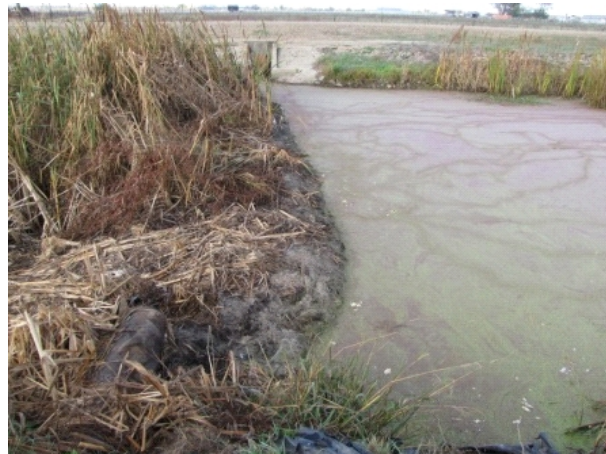
dpesaven_20091124_516.jpg

View of earthen dam taken looking across the channel.

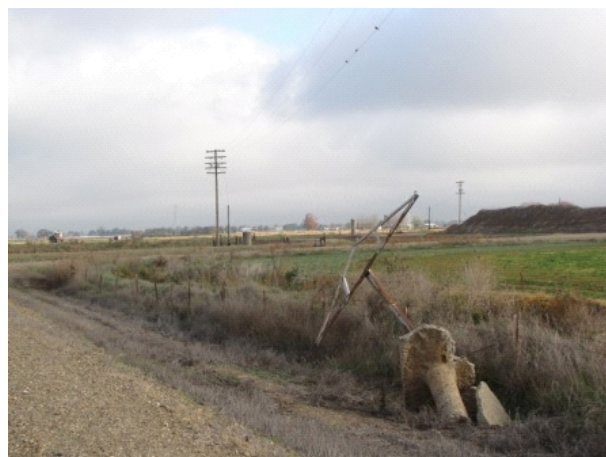
dpesaven_20091124_518.jpg

View of concrete and metal debris at the landward toe looking upstream.

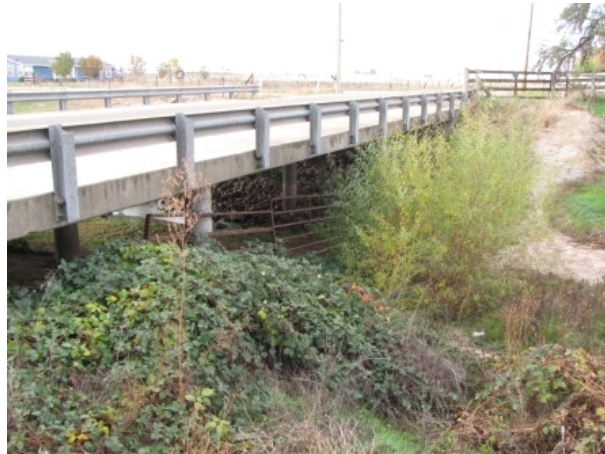
dpesaven_20091124_520.jpg

View of a gate that has been placed along the piers of the Sargent bridge creating a potential debris dam.

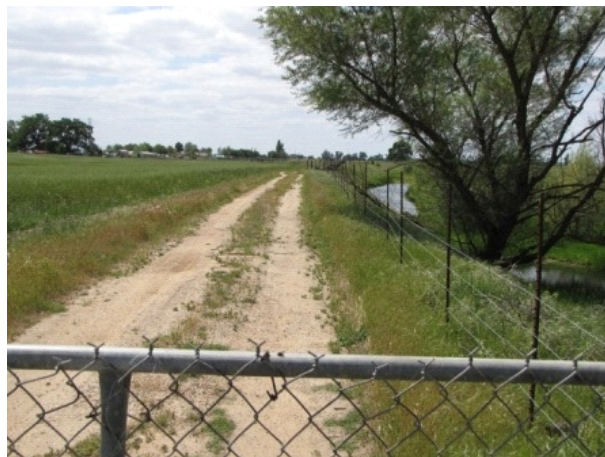
dpesaven_20091002_41.jpg

Fence along waterward sholder and crown of access road. The road cannot be driven through as the fence blocks access. The gate does not have a county key on the gate.

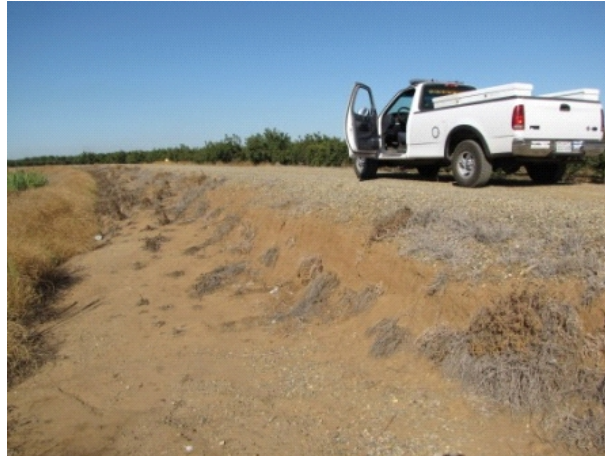
dpesaven_20091019_70.jpg

View of erosion of waterward levee slope looking upstream.

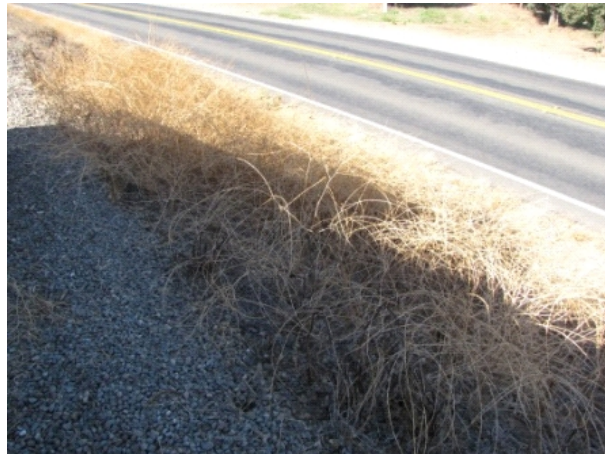
dpesaven_20091019_71.jpg

View of vegetation on landward slope looking upstream.

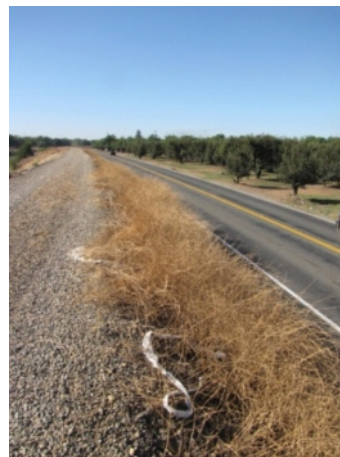
dpesaven_20091019_72.jpg

View of vegetation on landward slope looking upstream.

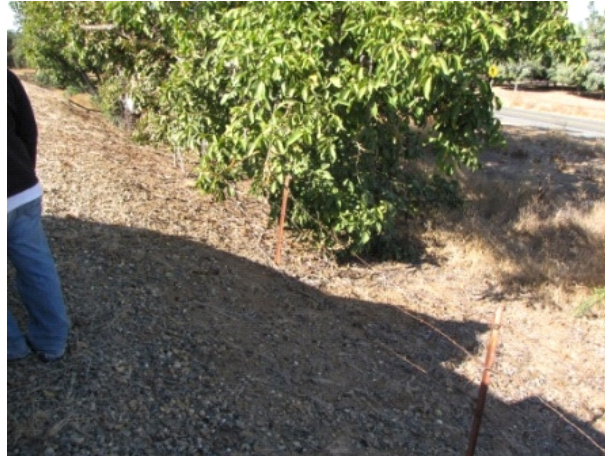
dpesaven_20091019_73.jpg

View of trees on landward slope looking upstream.

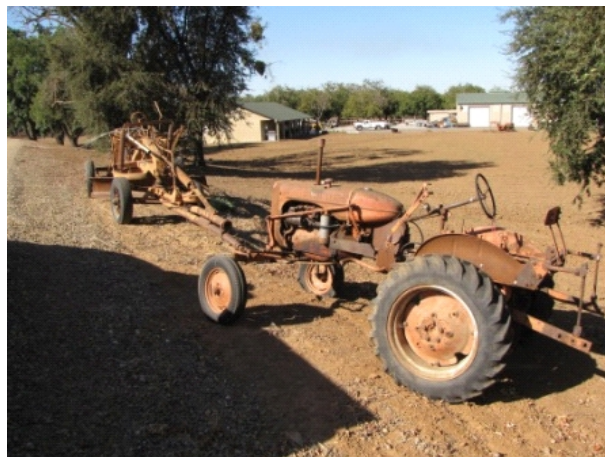
Levee Mile Report Line	9
Start Levee Mile	2.54
End Levee Mile	2.54
Location	Land Side
Category	Earthen Levee
Item	Encroachments

View of equipment on the landward slope of the levee looking upstream.

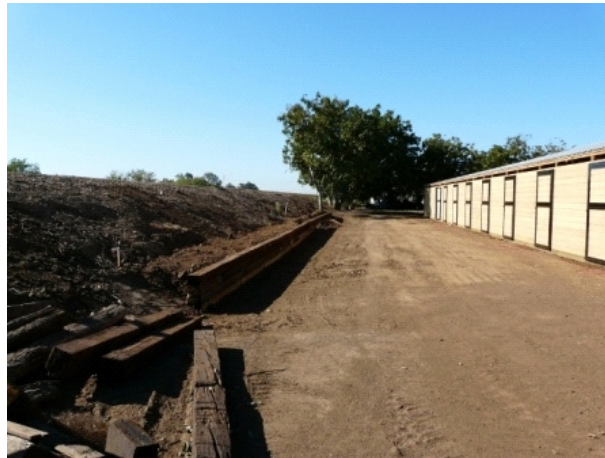
Recently built retaining wall at toe of landside levee at LM 2.68.

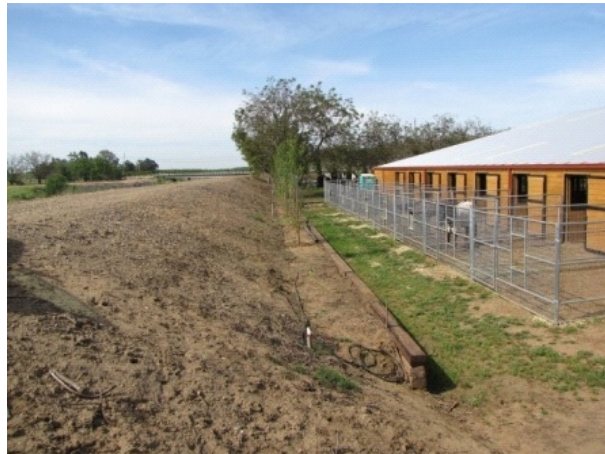
Levee Mile Report Line	12
Start Levee Mile	2.68
End Levee Mile	2.71
Location	Land Side
Category	Earthen Levee
Item	Encroachments

Updated view as of Spring 2009. Landscaping and irrigation has been added at the toe of the levee.

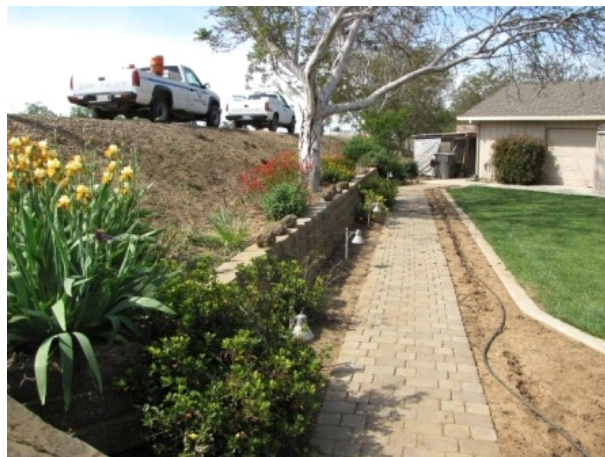
Levee Mile Report Line	14
Start Levee Mile	2.74
End Levee Mile	2.75
Location	Land Side
Category	Earthen Levee
Item	Encroachments

View of retaining wall and landscaping along the landward toe of the levee.

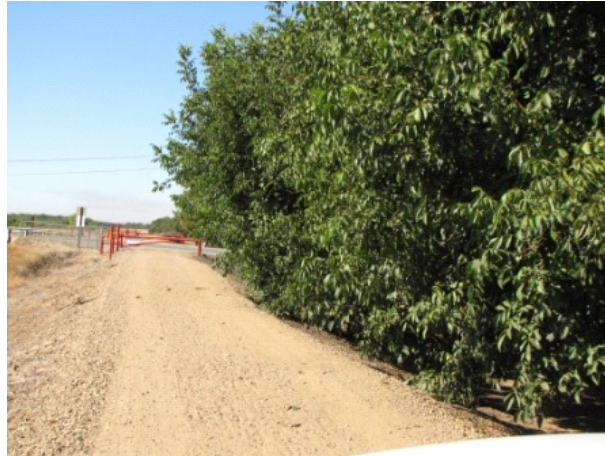
Levee Mile Report Line	15
Start Levee Mile	2.78
End Levee Mile	2.78
Location	Land Side
Category	Earthen Levee
Item	Trim / Thin Trees
View of trees obstructing view along landward slope looking upstream.	
dpesaven_20091019_76.jpg

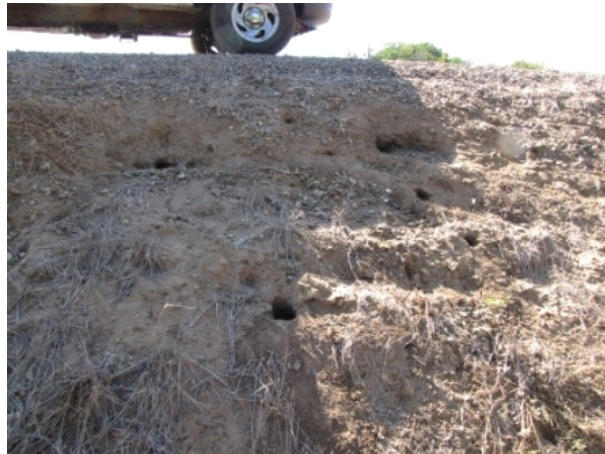
Levee Mile Report Line	26
Start Levee Mile	3.40
End Levee Mile	3.40
Location	Land Side
Category	Earthen Levee
Item	Animal Control
View of rodent holes on landward slope of levee.	
dpesaven_20091023_106.jpg

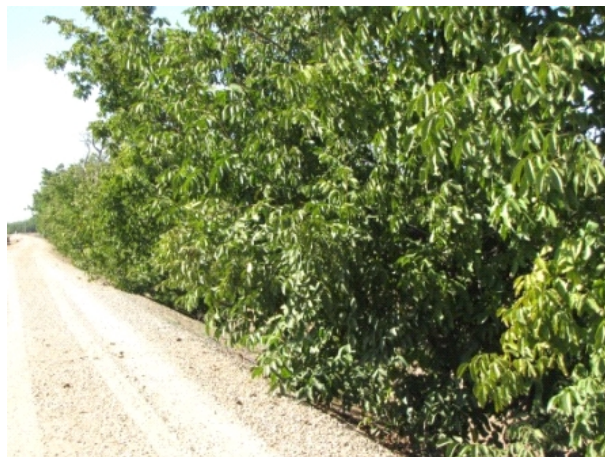
Levee Mile Report Line	27
Start Levee Mile	3.50
End Levee Mile	3.55
Location	Land Side
Category	Earthen Levee
Item	Trim / Thin Trees
View of trees obstructing the view and access along landward slope of levee looking downstream.	
dpesaven_20091023_107.jpg

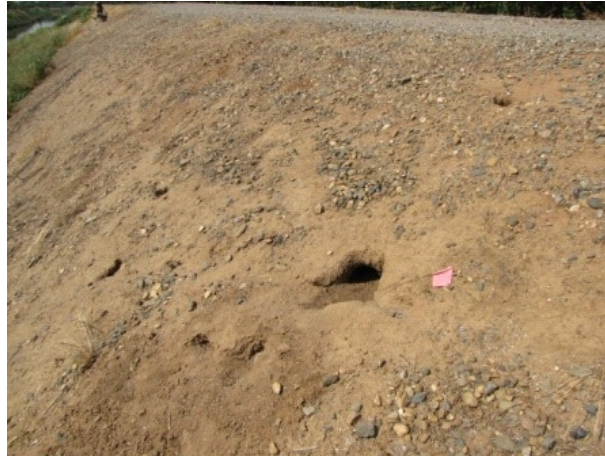
Example rodent hole in waterward slope of levee. There is some evidence of recent rodent activity.

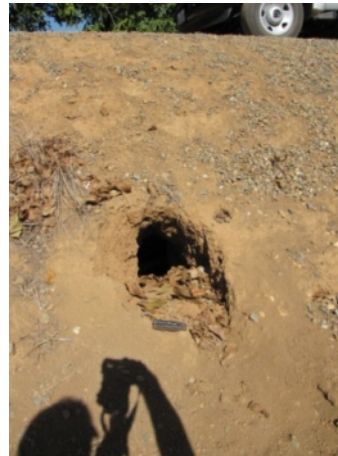
Levee Mile Report Line	28
Start Levee Mile	3.60
End Levee Mile	3.60
Location	Water Side
Category	Earthen Levee
Item	Animal Control

View of large hole in waterward slope of levee.

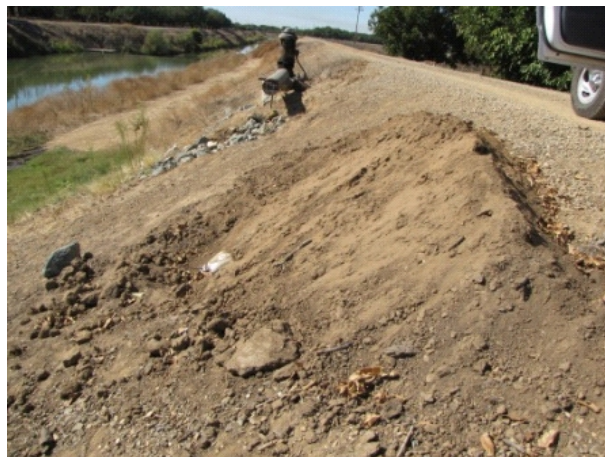
Levee Mile Report Line	30
Start Levee Mile	3.63
End Levee Mile	3.63
Location	Water Side
Category	Earthen Levee
Item	Slope Stability

30	3.63	3.63	Earthen Levee	Slope Stability	WS	M	Repair slope instability. Inspector Comments: A recent, unauthorized repair to an irrigation pipe has left the levee slope inadequately compacted. Landowner should re-compact the slope properly and submit documentation.	38.021589 ° -121.061291 °	38.021589 ° -121.061291 °	1003 Y
31	3.64	3.66	Earthen Levee	Slope Stability	LS	M	Repair slope instability. Inspector Comments: Landowner is scraping material from the toe and levee slope and piling it toward the landward shoulder. Material should be removed and levee slope recompacted.	38.021466 ° -121.061470 °	38.021218 ° -121.061752 °	1004 Y
32	3.94	4.10	Earthen Levee	Encroachments	LS	M	Prunings	38.018222 ° -121.065043 °	38.016537 ° -121.066789 °	1005 Y
33	4.14	4.14	Earthen Levee	Encroachments	LS	PO	Landscaping	38.016115 ° -121.067187 °	38.016115 ° -121.067187 °	16
34	4.22	4.22	Earthen Levee	Animal Control	WS	M	Exterminate rodents and backfill and compact or grout burrows.	38.014965 ° -121.067482 °	38.014965 ° -121.067482 °	966

View of fresh material along waterward slope of levee looking downstream.

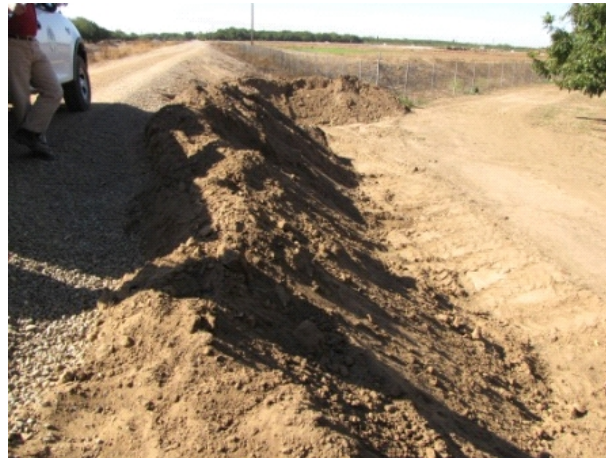
View of excavations and embankments created by landowner along the landward slope looking downstream.

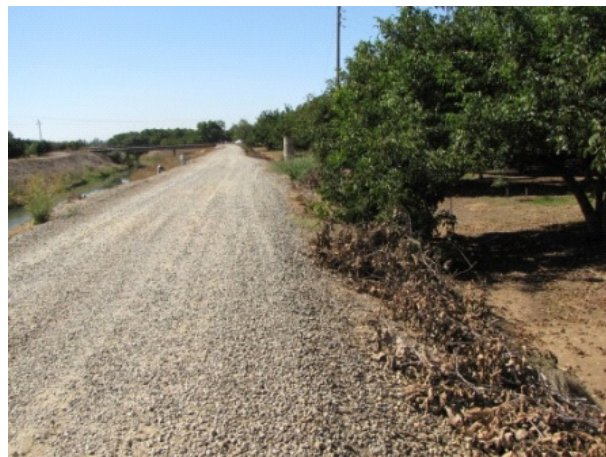
Levee Mile Report Line	32
Start Levee Mile	3.94
End Levee Mile	4.10
Location	Land Side
Category	Earthen Levee
Item	Encroachments

View of prunings placed on landward slope by landowner looking downstream.

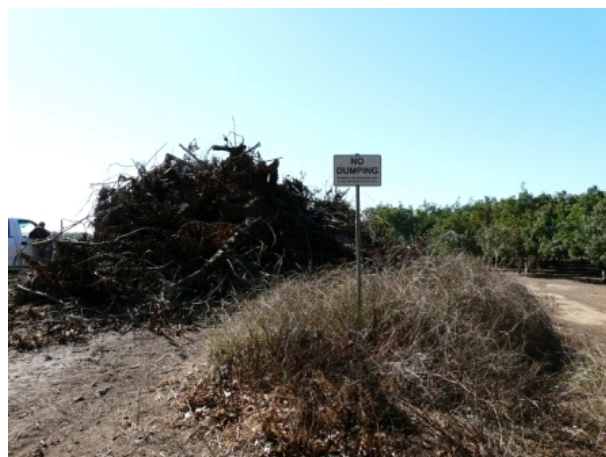
Levee Mile Report Line	37
Start Levee Mile	4.29
End Levee Mile	4.29
Location	Land Side
Category	Earthen Levee
Item	Encroachments

Example of a prunings pile immediately adjacent to access road at LM 4.29. Evidence of habitual burnings at this site.

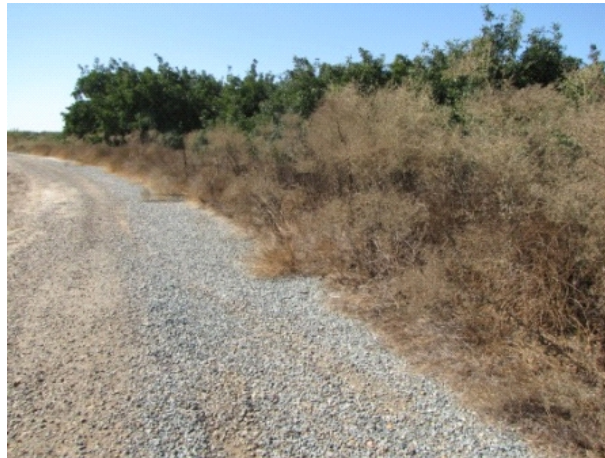
View of excessive vegetation along the landward slope of the levee looking downstream.

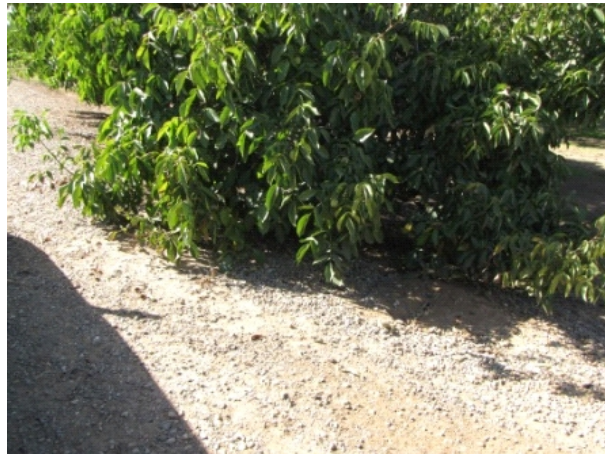
Levee Mile Report Line	39
Start Levee Mile	4.67
End Levee Mile	4.67
Location	Land Side
Category	Earthen Levee
Item	Trim / Thin Trees

View of a tree blocking visibility and access along the landward slope.

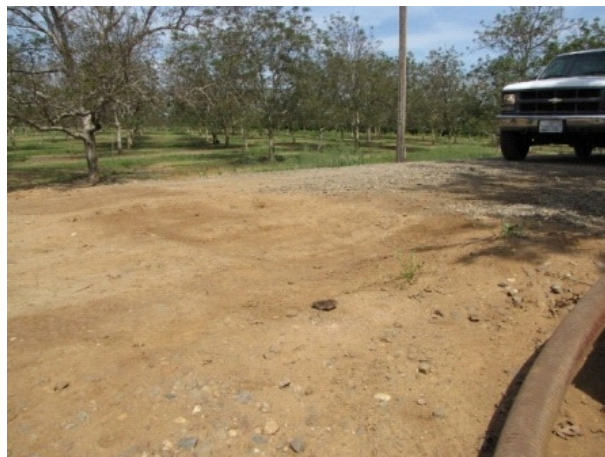
Levee Mile Report Line	40
Start Levee Mile	4.75
End Levee Mile	4.75
Location	Land Side
Category	Earthen Levee
Item	Crown Surface / Depressions / Rutting

Depression in roadway due to maintenance performed on a pipe penetration. The depression is a sign that the backfill material may not have been compacted properly. Recompact levee material and re-grade the levee crown.

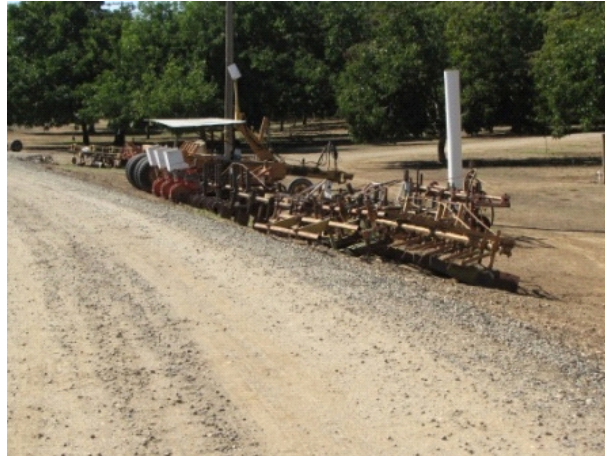
View of equipment along the landward slope looking downstream.

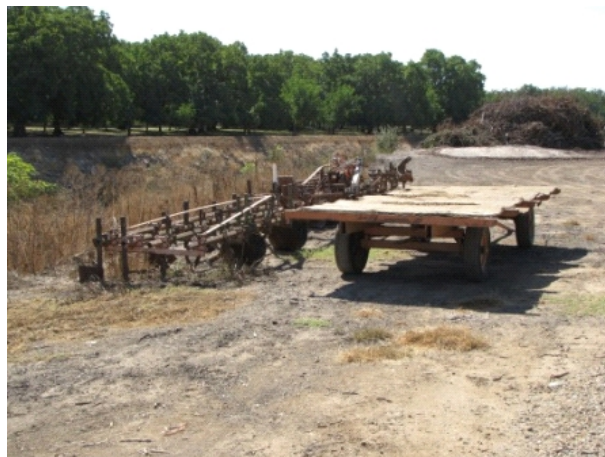
Levee Mile Report Line	42
Start Levee Mile	4.96
End Levee Mile	4.96
Location	Water Side
Category	Earthen Levee
Item	Encroachments

View of equipment along the waterward side of the levee crown looking downstream.

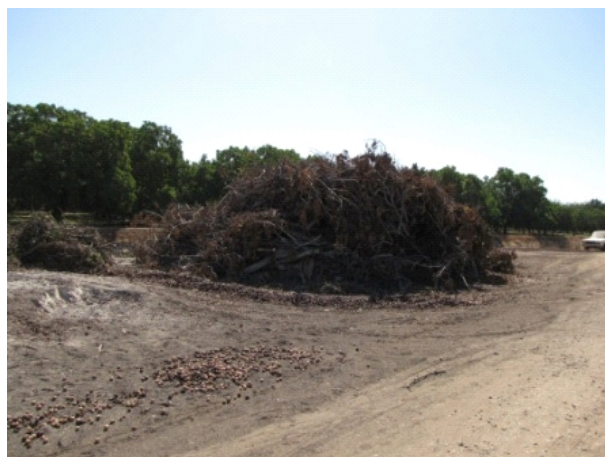
Levee Mile Report Line	43
Start Levee Mile	4.97
End Levee Mile	4.97
Location	Water Side
Category	Earthen Levee
Item	Encroachments

View of prunings pile along the waterward side of the crown looking downstream.

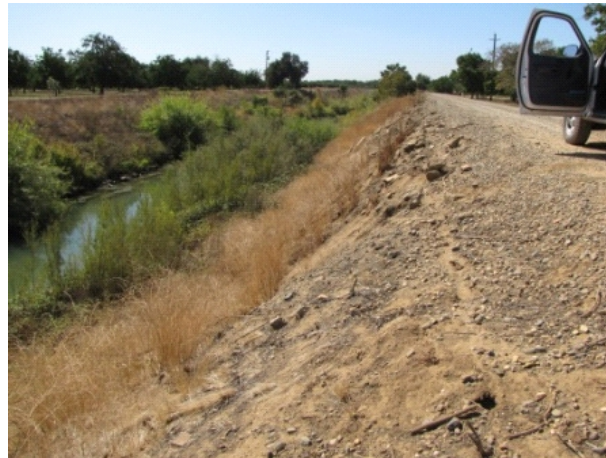
View of a slip in the waterward levee slope looking downstream.

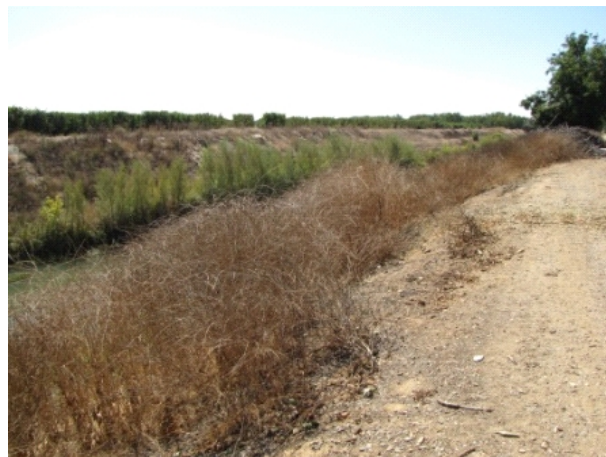
Levee Mile Report Line	49
Start Levee Mile	5.31
End Levee Mile	5.34
Location	Water Side
Category	Earthen Levee
Item	Vegetation

View of vegetation blocking visibility and access along the waterward slope looking downstream.

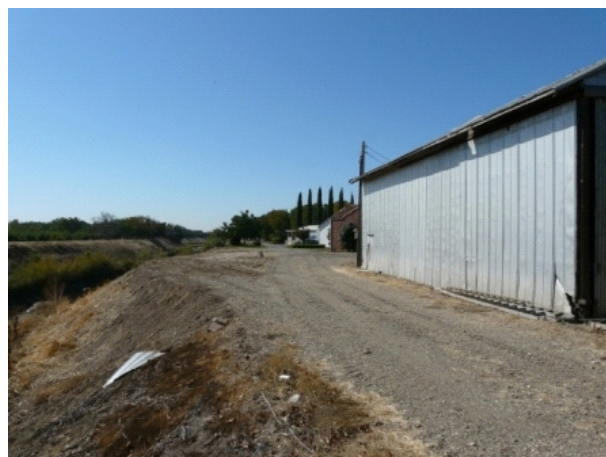
Levee Mile Report Line	51
Start Levee Mile	5.38
End Levee Mile	5.45
Location	Land Side
Category	Earthen Levee
Item	Encroachments

Building located immediately adjacent to access road approximately from LM 5.38 to 5.45

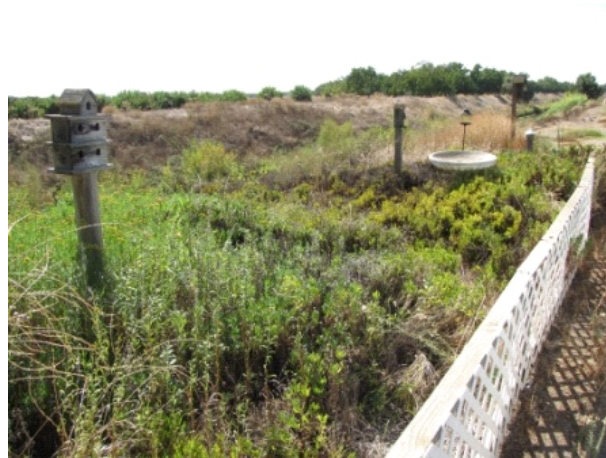
View of landscaping planted along the waterward side of the access road impacting visibility and the ability to floodfight looking downstream.

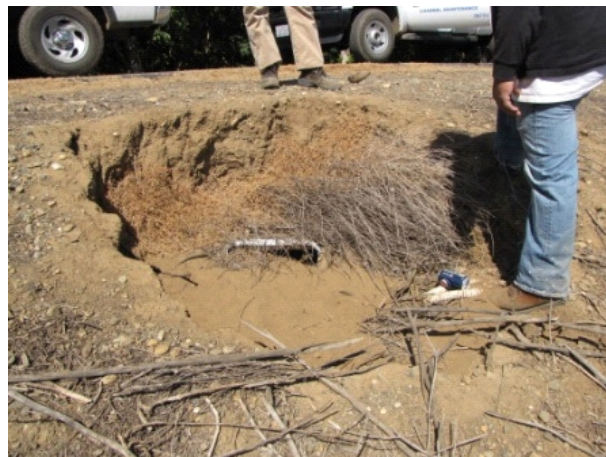
Levee Mile Report Line	53
Start Levee Mile	5.50
End Levee Mile	5.50
Location	Water Side
Category	Earthen Levee
Item	Erosion / Bank Caving

View of erosion occurring along the waterward slope of the levee.

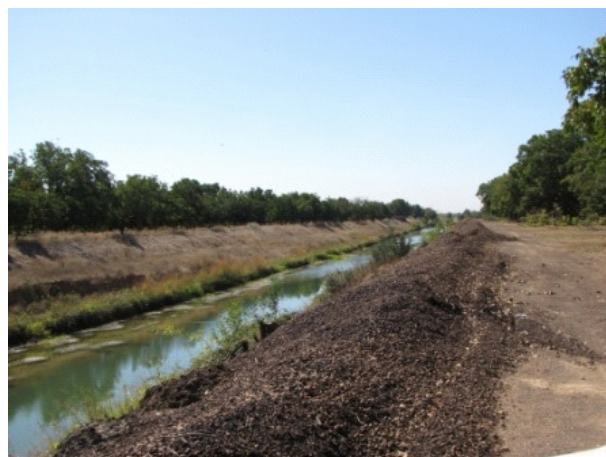
Levee Mile Report Line	54
Start Levee Mile	5.60
End Levee Mile	5.65
Location	Water Side
Category	Earthen Levee
Item	Encroachments

View of discarded nut shells placed along the waterward slope to be burned looking downstream.

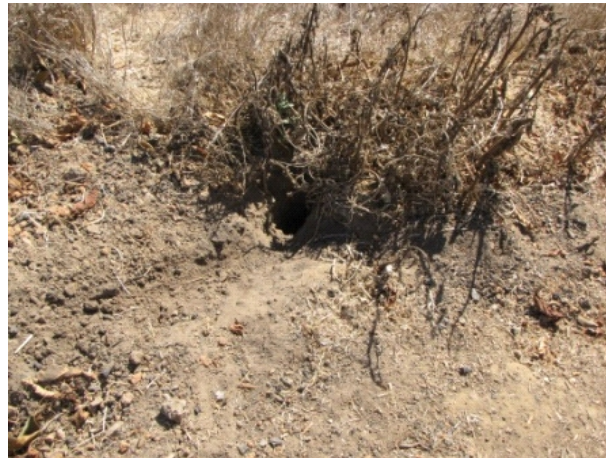
View of an example rodent hole in the waterward slope of the levee.

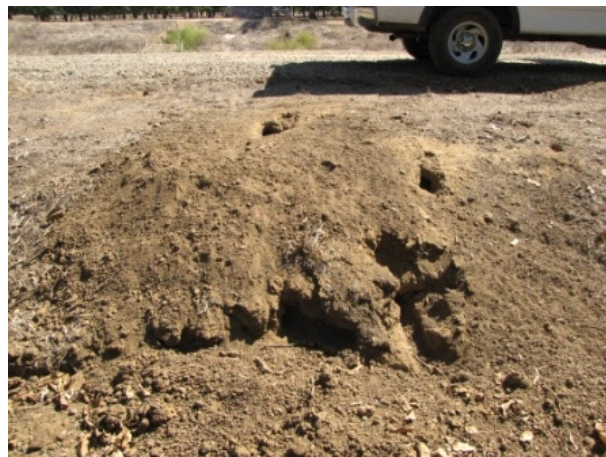
Levee Mile Report Line	60
Start Levee Mile	6.57
End Levee Mile	6.57
Location	Land Side
Category	Earthen Levee
Item	Animal Control

View of rodent holes in the landward slope of the levee.

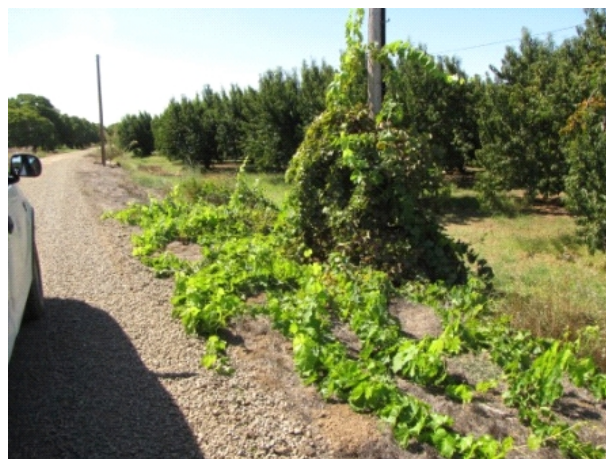
Levee Mile Report Line	62
Start Levee Mile	6.68
End Levee Mile	6.68
Location	Land Side
Category	Earthen Levee
Item	Encroachments

View of landscaping along the landward slope looking downstream.

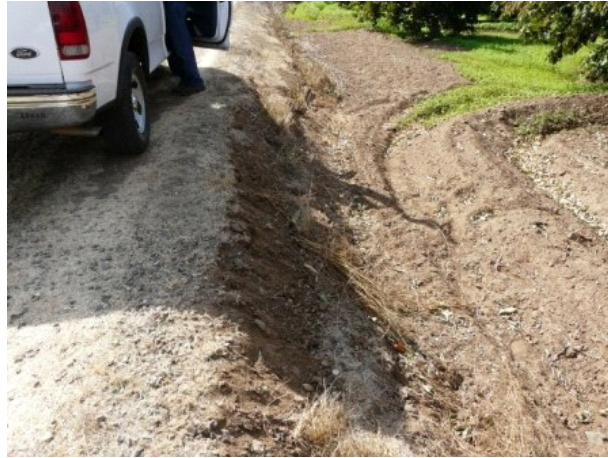
Farming equipment grading into the landside toe of the levee located at LM 6.90. Backfill and compact to design shape and attempt to prevent future damage.

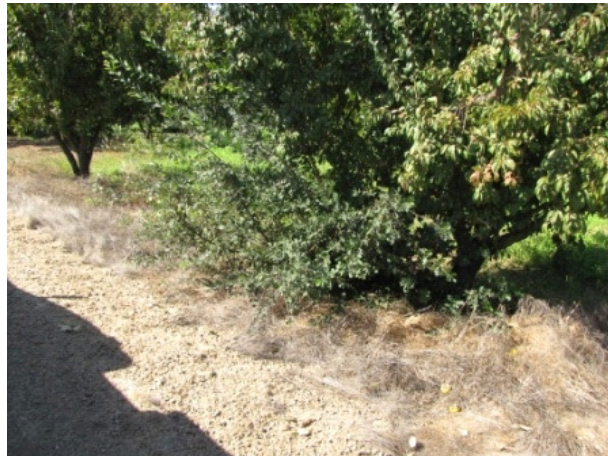
Levee Mile Report Line	64
Start Levee Mile	6.91
End Levee Mile	6.91
Location	Land Side
Category	Earthen Levee
Item	Trim / Thin Trees

View of trees obstructing visibility and the ability to floodfight along the landward slope.

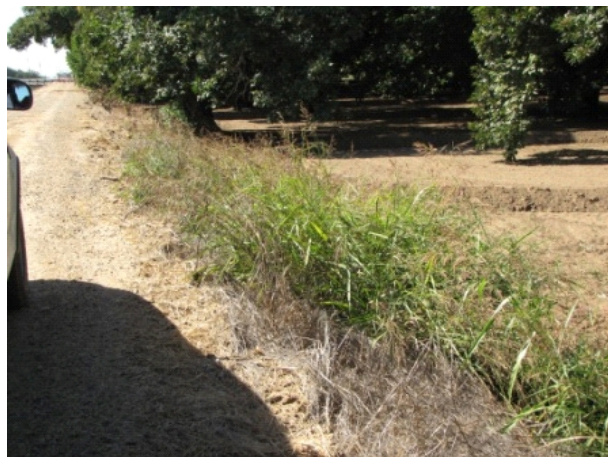
Levee Mile Report Line	66
Start Levee Mile	6.96
End Levee Mile	6.96
Location	Land Side
Category	Earthen Levee
Item	Vegetation

View of excessive vegetation along the landward slope of the levee.

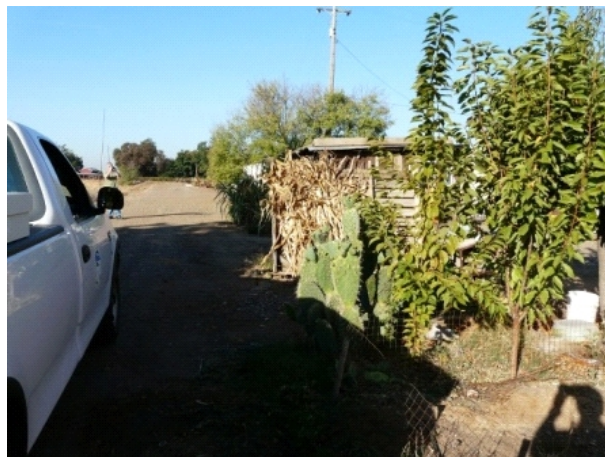
Levee Mile Report Line	84
Start Levee Mile	8.72
End Levee Mile	8.72
Location	Land Side
Category	Earthen Levee
Item	Encroachments
Building, fence and landscaping immediately adjacent to the access road at LM 8.72.	
dpesaven_20091002_11.JPG

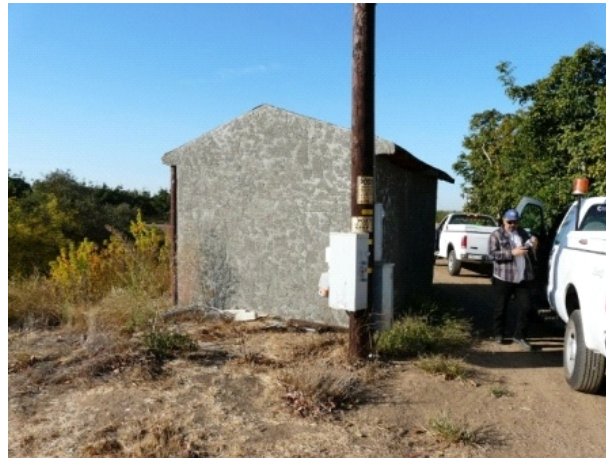
Levee Mile Report Line	93
Start Levee Mile	9.63
End Levee Mile	9.63
Location	Water Side
Category	Earthen Levee
Item	Encroachments
Building located at LM 9.63 on waterside of access road. This building appears to be recently constructed and does not currently contain anything.	
dpesaven_20091002_5.JPG

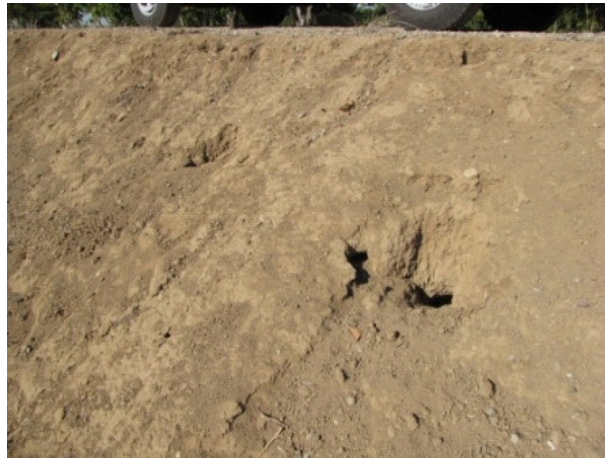
View of rodent holes in the waterward slope.

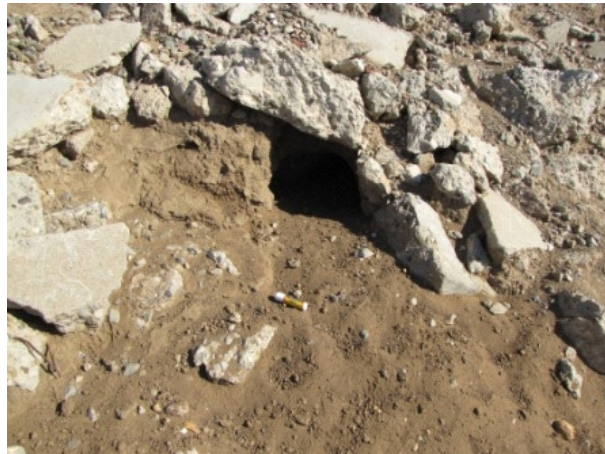
Levee Mile Report Line	105
Start Levee Mile	11.20
End Levee Mile	11.20
Location	Water Side
Category	Earthen Levee
Item	Animal Control

View of rodent hole in the waterward slope. Note the size relative to the chapstick.

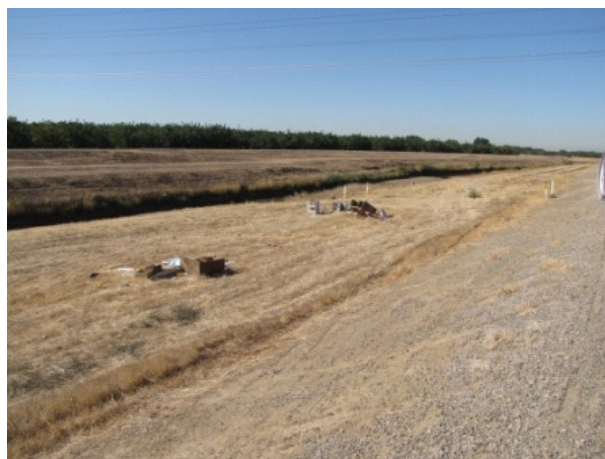
Levee Mile Report Line	109
Start Levee Mile	12.63
End Levee Mile	12.63
Location	Water Side
Category	Earthen Levee
Item	Encroachments

View of debris piles along the waterward toe of the levee looking downstream.

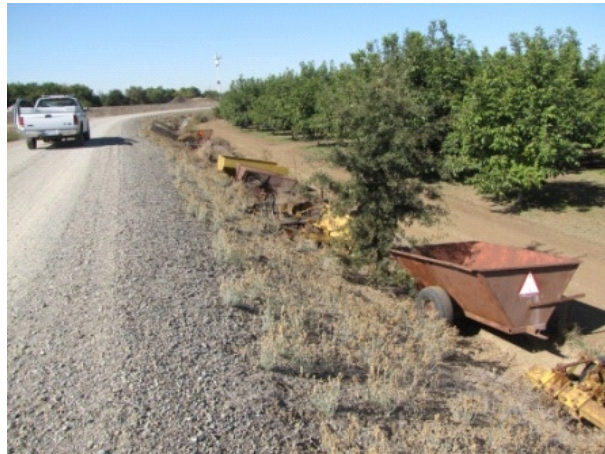
Levee Mile Report Line	116
Start Levee Mile	13.59
End Levee Mile	13.74
Location	Land Side
Category	Earthen Levee
Item	Encroachments

View of trees planted on the landward levee slope and toe looking downstream.

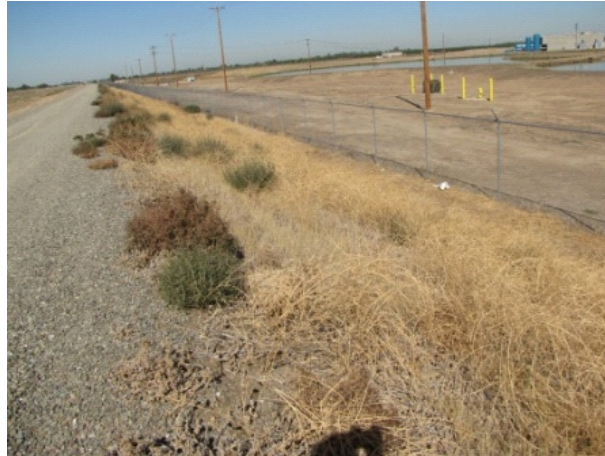
Levee Mile Report Line	118
Start Levee Mile	14.35
End Levee Mile	14.82
Location	Land Side
Category	Earthen Levee
Item	Vegetation

View of excessive vegetation blocking visibility and access along the landward toe looking downstream.

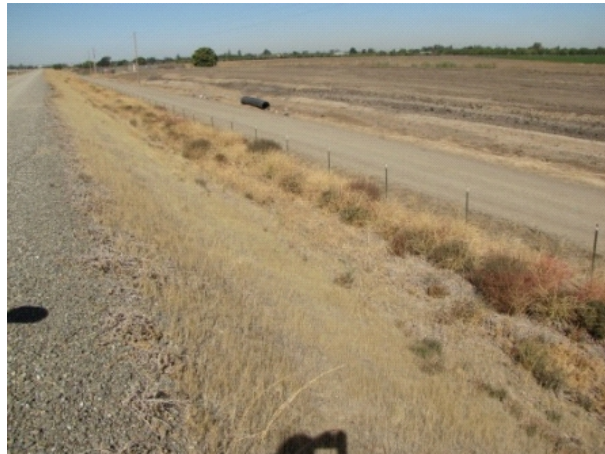
Levee Mile Report Line	120
Start Levee Mile	15.64
End Levee Mile	15.64
Location	Land Side
Category	Earthen Levee
Item	Vegetation

View of excessive vegetation along the landward toe blocking visibility and access.

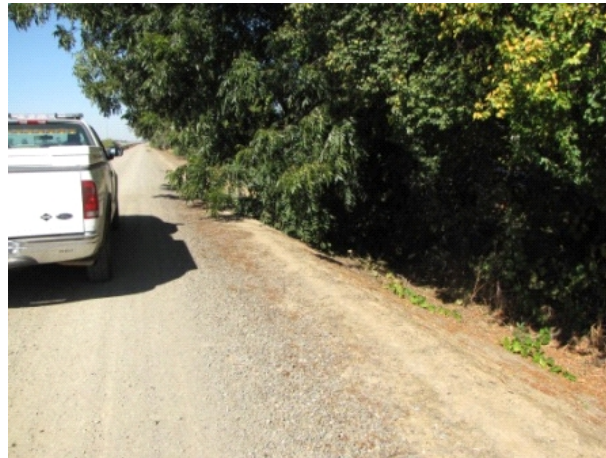
Levee Mile Report Line	122
Start Levee Mile	15.94
End Levee Mile	15.94
Location	Land Side
Category	Earthen Levee
Item	Encroachments
View of trees planted and maintained by the landowner along the landward toe looking downstream.	
dpesaven_20091026_138.jpg

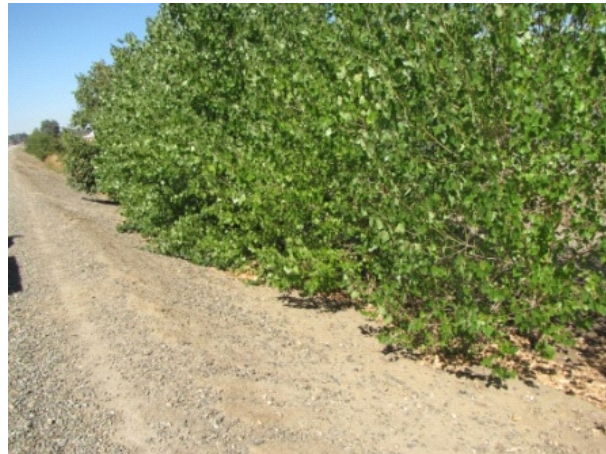
Levee Mile Report Line	123
Start Levee Mile	15.99
End Levee Mile	15.99
Location	Land Side
Category	Earthen Levee
Item	Trim / Thin Trees
View of a tree blocking visibility and access along the landward toe.	
dpesaven_20091026_139.jpg

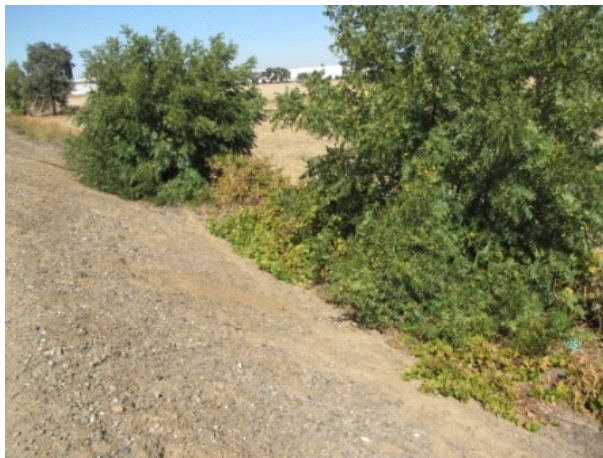
Levee Mile Report Line	125
Start Levee Mile	16.09
End Levee Mile	16.60
Location	Land Side
Category	Earthen Levee
Item	Encroachments

View of a ditch adjacent to the landward toe looking downstream.

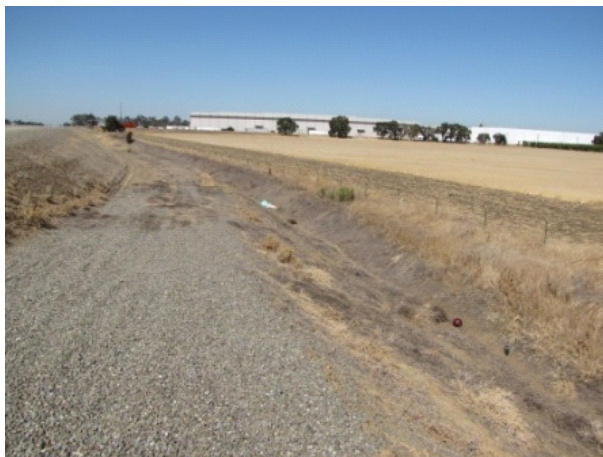
Levee Mile Report Line	127
Start Levee Mile	17.03
End Levee Mile	17.03
Location	Land Side
Category	Earthen Levee
Item	Vegetation

View of excessive vegetation blocking visibility and access along the landward slope looking downstream.

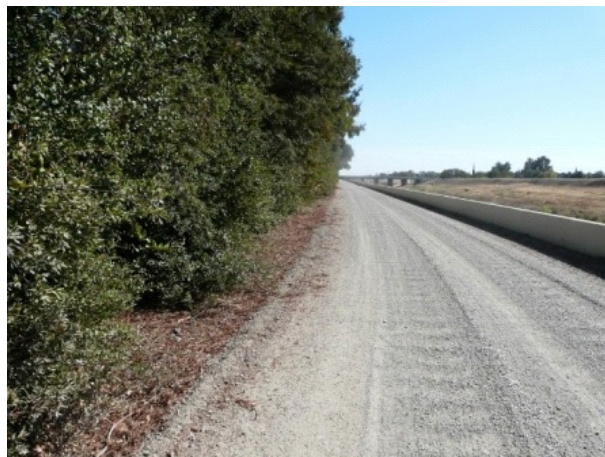
Levee Mile Report Line	131
Start Levee Mile	18.27
End Levee Mile	18.27
Location	Land Side
Category	Earthen Levee
Item	Trim / Thin Trees

View of a tree blocking visibility and access along the landward slope.

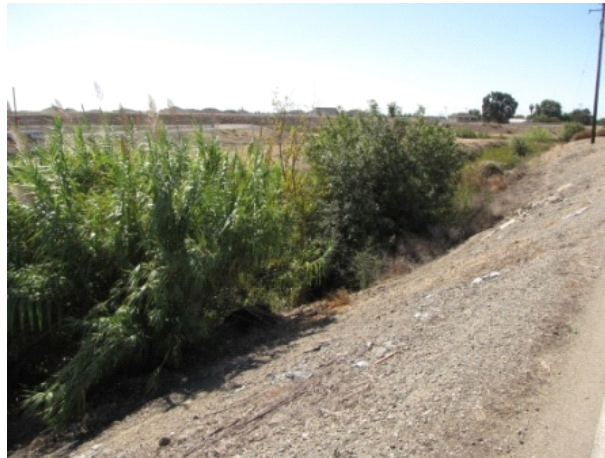
Levee Mile Report Line	136
Start Levee Mile	19.80
End Levee Mile	19.86
Location	Land Side
Category	Earthen Levee
Item	Encroachments

View of landowner planted and maintained vegetation along the landward slope looking downstream.

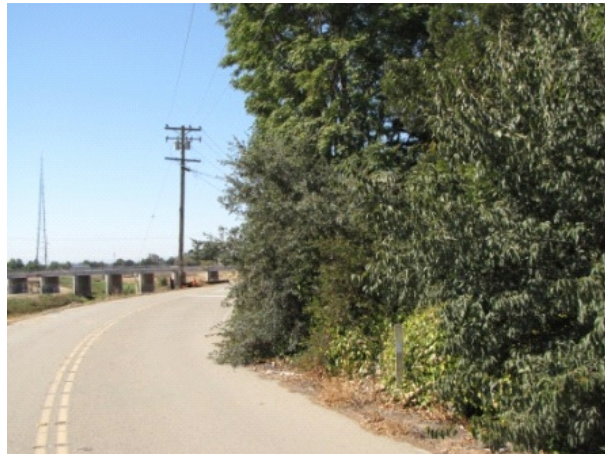
Levee Mile Report Line	138
Start Levee Mile	20.13
End Levee Mile	20.13
Location	Land Side
Category	Earthen Levee
Item	Trim / Thin Trees

View of tree on landward slope blocking visibility and access.

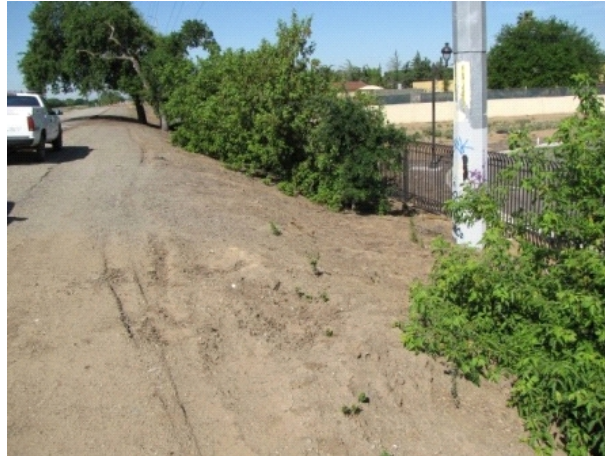
Levee Mile Report Line	139
Start Levee Mile	20.37
End Levee Mile	20.39
Location	Land Side
Category	Earthen Levee
Item	Trim / Thin Trees

Updated view of trees on landward slope blocking visibility and access looking downstream.

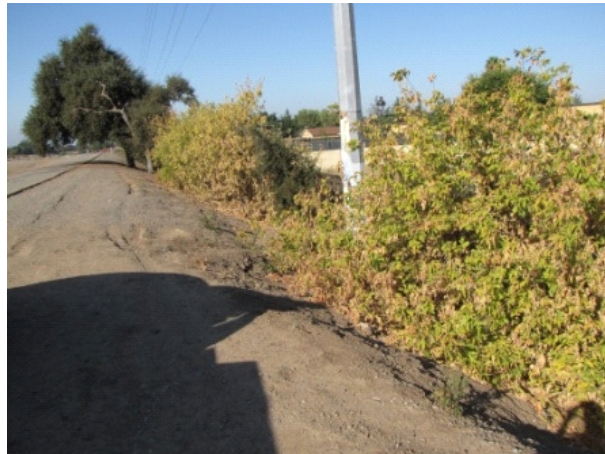
Levee Mile Report Line	140
Start Levee Mile	20.44
End Levee Mile	20.44
Location	Land Side
Category	Earthen Levee
Item	Vegetation

View of excessive vegetation blocking visibility and access along landward slope looking downstream.

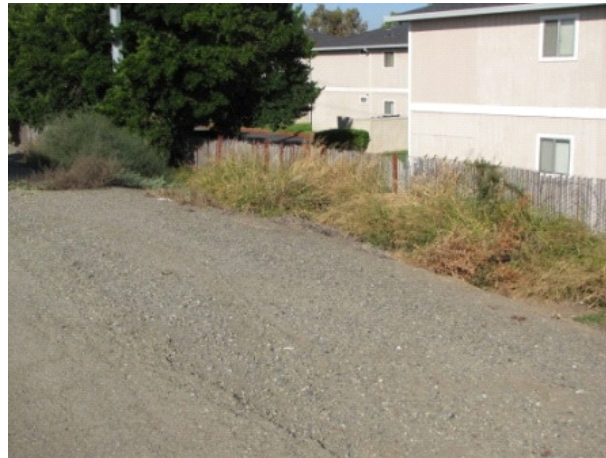
Levee Mile Report Line	142
Start Levee Mile	20.57
End Levee Mile	20.64
Location	Land Side
Category	Earthen Levee
Item	Vegetation

View of excessive vegetation along the landward slope looking downstream.

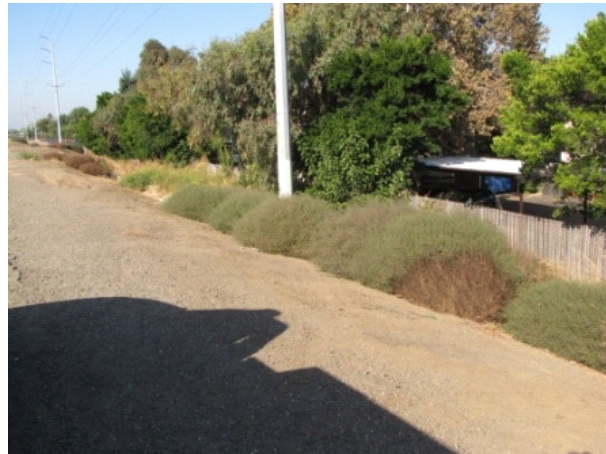
Levee Mile Report Line	143
Start Levee Mile	20.74
End Levee Mile	20.74
Location	Land Side
Category	Earthen Levee
Item	Vegetation

View of excessive vegetation blocking visibility and access along the landward slope of the levee looking downstream.

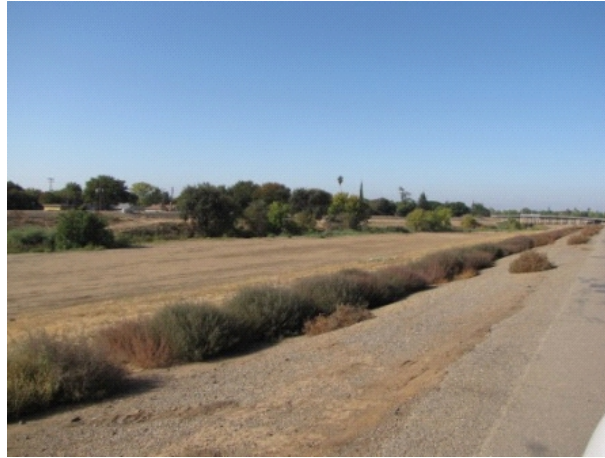
Levee Mile Report Line	148
Start Levee Mile	21.46
End Levee Mile	21.61
Location	Land Side
Category	Earthen Levee
Item	Encroachments

View of fence along the landward toe looking downstream.

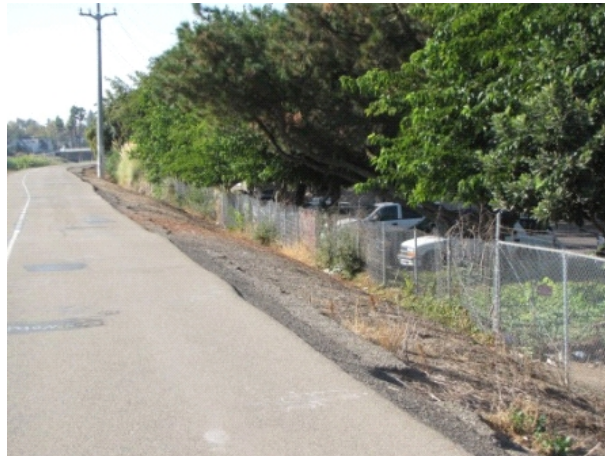
Levee Mile Report Line	149
Start Levee Mile	21.52
End Levee Mile	21.73
Location	Land Side
Category	Earthen Levee
Item	Encroachments

View of landscaping along the landward slope and toe looking downstream.

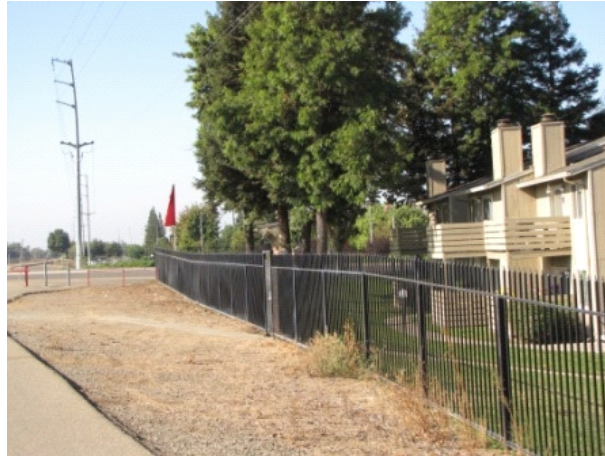
Levee Mile Report Line	151
Start Levee Mile	22.07
End Levee Mile	22.07
Location	Land Side
Category	Earthen Levee
Item	Trim / Thin Trees

View of trees blocking visibility along the landward toe.

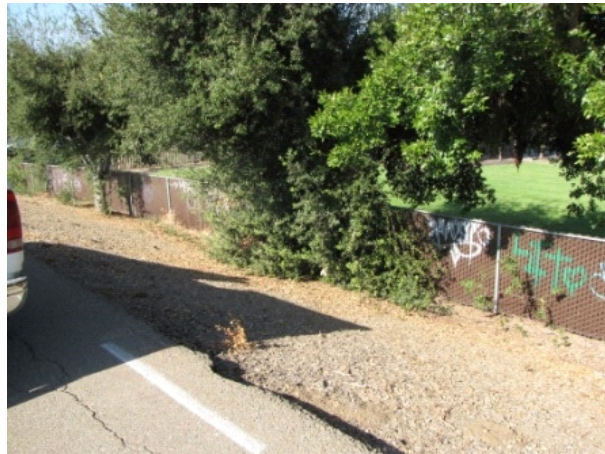
Levee Mile Report Line	152
Start Levee Mile	22.11
End Levee Mile	22.11
Location	Land Side
Category	Earthen Levee
Item	Encroachments

View of landscaping maintained by UOP along the landward slope looking downstream.

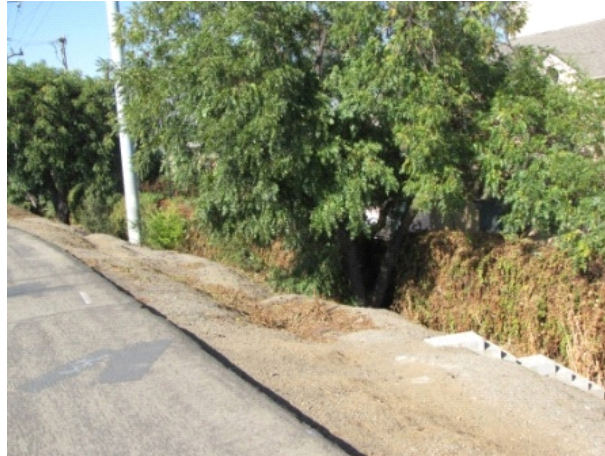
Levee Mile Report Line	154
Start Levee Mile	22.36
End Levee Mile	22.37
Location	Land Side
Category	Earthen Levee
Item	Encroachments

Fence located from LM 22.36 to LM 22.37 significantly encroaches onto landside levee slope.

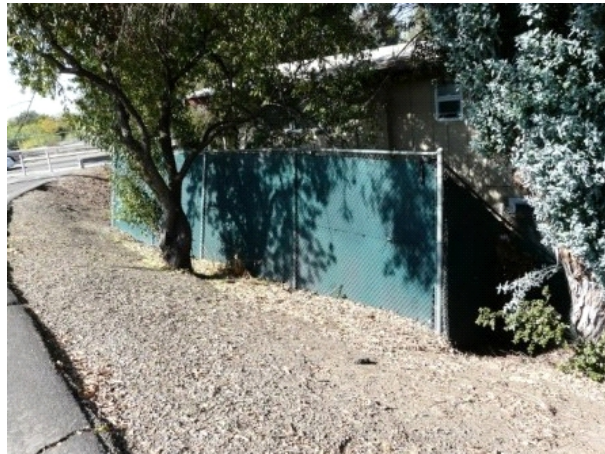
Levee Mile Report Line	155
Start Levee Mile	22.40
End Levee Mile	22.43
Location	Land Side
Category	Earthen Levee
Item	Vegetation

View of vegetation blocking visibility and access along the landward slope and toe looking downstream.

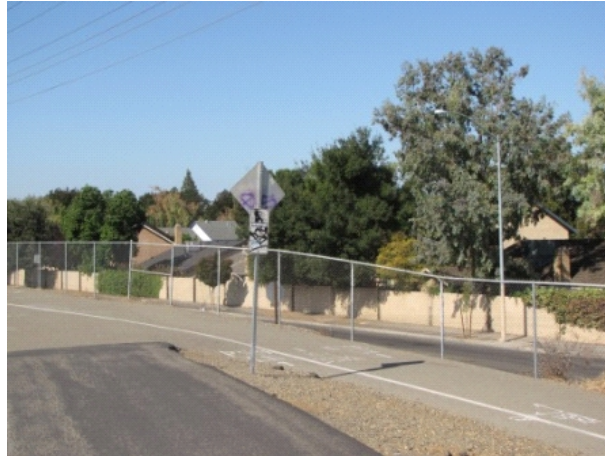
Levee Mile Report Line	157
Start Levee Mile	23.54
End Levee Mile	23.69
Location	Land Side
Category	Earthen Levee
Item	Encroachments

View of fence along landward shoulder looking downstream.

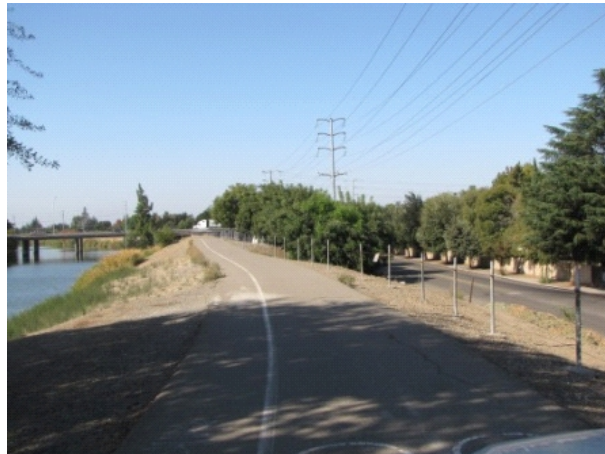
Levee Mile Report Line	158
Start Levee Mile	23.59
End Levee Mile	23.59
Location	Land Side
Category	Earthen Levee
Item	Trim / Thin Trees

View of a tree along the landward slope blocking visibility and access.

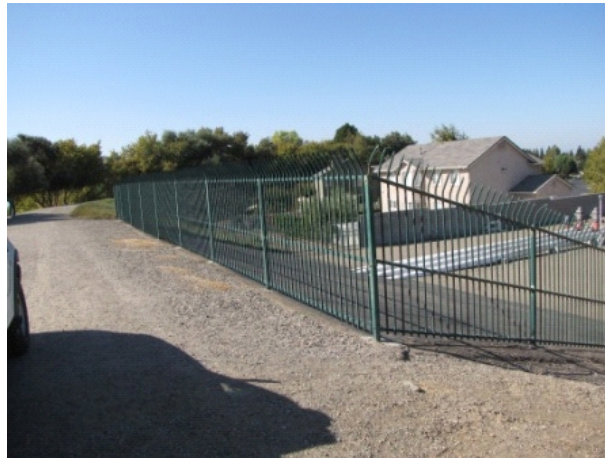
Levee Mile Report Line	160
Start Levee Mile	24.21
End Levee Mile	25.62
Location	Land Side
Category	Earthen Levee
Item	Encroachments

View of typical landowner planted and maintained landscaping and irrigation along the landward shoulder, slope, and toe looking downstream.
